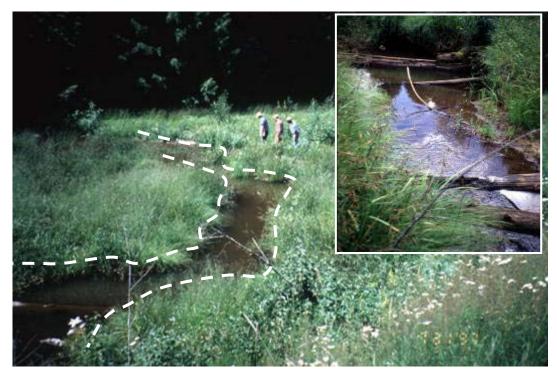
**Figure 35**—large logs, such as the cedar logs shown in the inset picture, with continuous vegetation over the top as shown above are not included in the greenline composition.

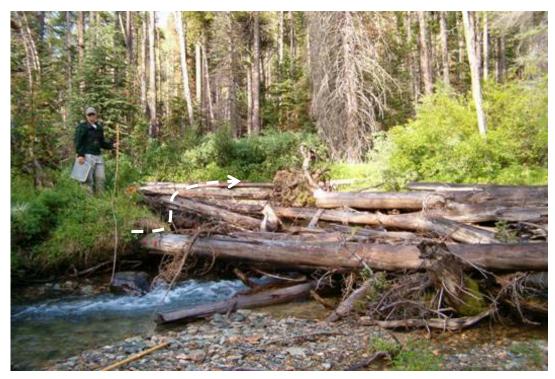
**Figure 36**—when a log jam that crosses the stream is encountered, the greenline continues over the log jam and is recorded as anchored wood. Photo - PIBO, U.S. Forest Service

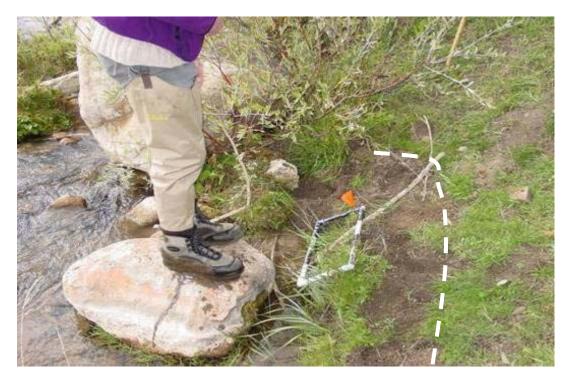
**Figure 37**—greenline is along the relatively continuous line. The patch of vegetation that the quadrant is on does not meet the 15 cm (6 in) by 50 cm (19.6 in) rule. The rock has erosion around the bank side and is not anchored to the streambank. The plot is moved perpendicular to the stream flow until adequate vegetation is within the quadrat.

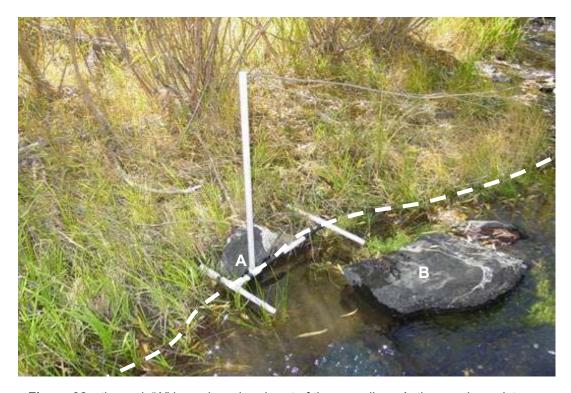
**Figure 38**—the rock "A" is anchored and part of the greenline. Active erosion exists on the streambank side of rock "B" and is not considered part of the greenline.

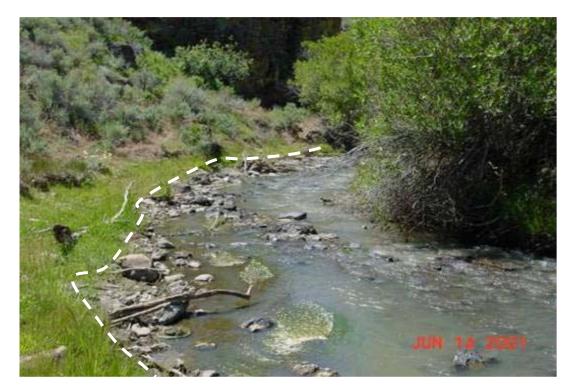
Figure 39—greenline follows the vegetation.

**Figure 40**—greenline follows the line of relatively continuous with lineal groupings of perennial vegetation with 25 percent foliar cover. Streambank alteration has broken the lineal grouping of vegetation shown in Figure 39.

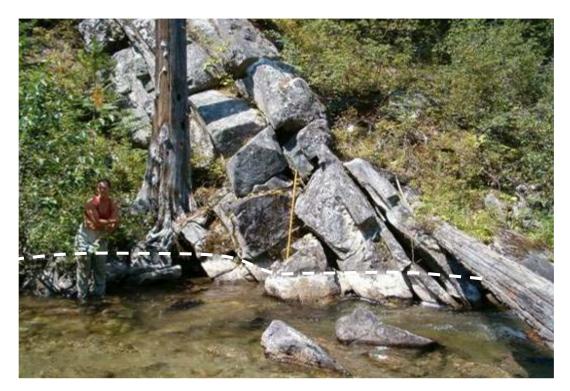
**Figure 41**—large anchored boulders and bedrock are recorded as rock. Note the color change on the rocks indicating the bankfull stage. *Photo - PIBO, U.S. Forest Service*

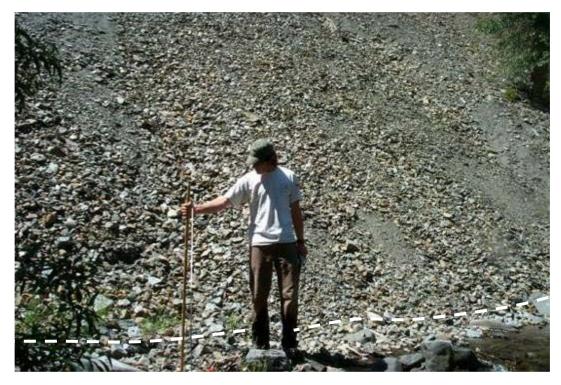
**Figure 42**—the greenline along talus a slope is considered as rock and is at about the bankfull stream level. Record the data as rock. *Photo - PIBO, U.S. Forest Service*
